BUILDING NOTE

NUMBER 47-2007

USE OF UNTREATED SOFTWOODS IN AREAS WHERE EUROPEAN HOUSE BORER HAS BEEN FOUND

Advisory Note #10

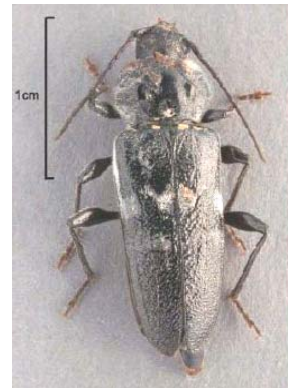
- Adult beetles that are dark brown to black and appear slightly flattened. Beetle wings are usually black but may have distinctive white patches. Behind the head there are two raised, black, shiny knobs, which are like eyes. Adults are about 18-25mm long with antennae about half that length.
